Sixty inappropriate defibrillation shocks in several days due to lead displacement

D Korpas, J Haluzikova, M Penhaker, M Augustynek. Sixty inappropriate defibrillation shocks in several days due to lead displacement. *Curr Res Cardiol* 2016;3(1):27-28.

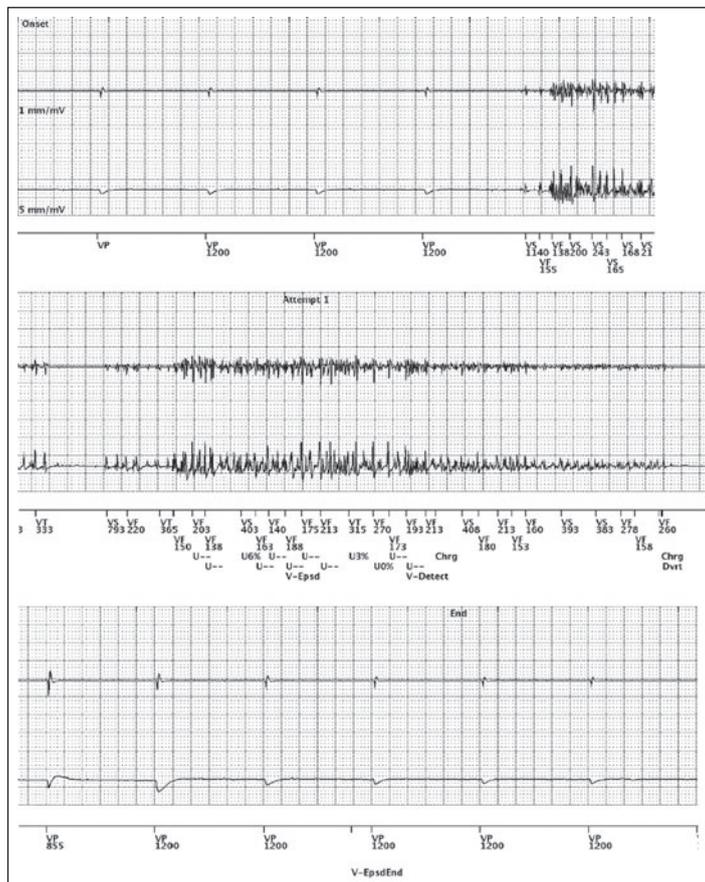
A typical episode stored in the device memory is shown in Figure 1. High and random frequency, low and variable amplitude, presented similarly in both the pace/sense and shock channels, are typical for

so-called 'lead rubbing'. This can usually occur between the old ventricular pace/sense lead connected in the IS-1 ventricular port and the distal shock coil of the newly implanted defibrillator lead in the re-implanted single-chamber ICD system. However, this patient has only one lead and, moreover, with a DF4 connector.

The reason for lead rubbing was displacement of the defibrillator lead into the superior vena cava. This was also confirmed by fluoroscopy. The diameter of the superior vena cava in this overweight patient was sufficient for the lead to 'kink', causing mechanical contact between the integrated sensing electrode and lead body during any patient movement. The overall number of false therapy shocks was impressive. To our knowledge, such a high number of shocks has never been reported. Surprisingly, the ICD battery was uncompromised, still predicting the full capacity of 12 years.

Figure 1) One of the many episodes extracted from the device memory, untreated in this case. **Top panel:** ventricular intracardiac electrogram used for tachyarrhythmia detection. **Middle panel:** shock coil electrogram (far-field). **Bottom panel:** marker annotations. Numbers represent appropriate cycle lengths in ms
