# Failure properties of leaf valve inflatable saline breast implants

Walter Peters PhD MD FRCSC

**Key Words:** *Failure, Saline breast implants*

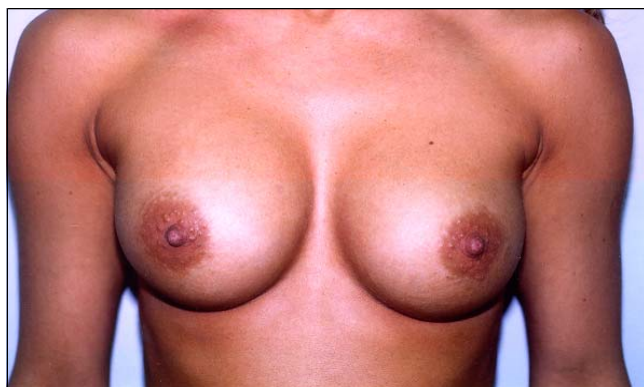
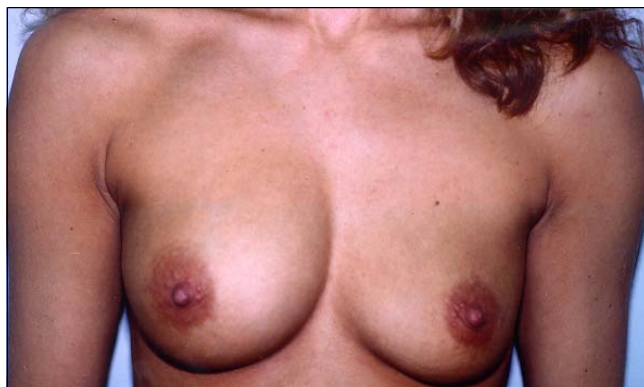
**Figure 1** **Top** Patient two months after implantation (the upper pole of the left breast is already smaller than that of the right breast). **Bottom** Ten months after implantation, with total deflation of the left implant (Implant 9, Table 1)

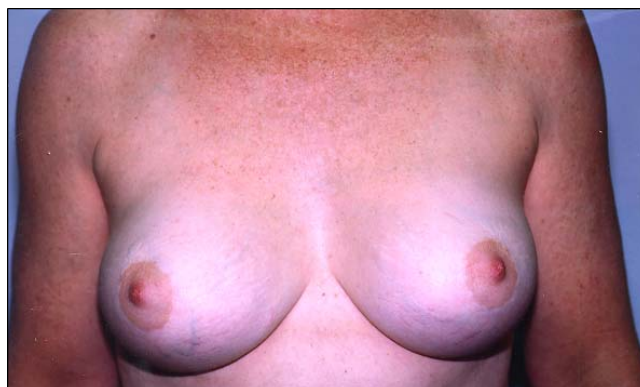
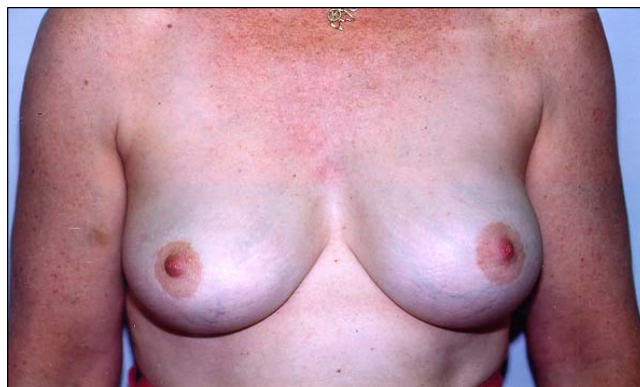
**Figure 2** **Top** Patient two months after implantation. **Bottom** Patient six months after implantation with partial deflation of the right implant (Implant 8, Table 1)

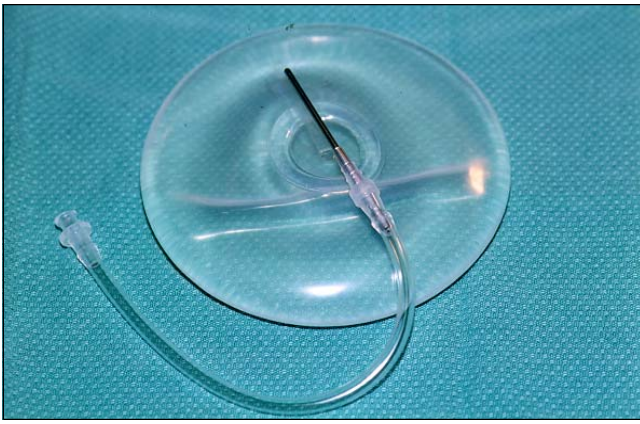
**Figure 3)** The Mentor Model 1800 leaf valve inflatable saline implant. Saline is injected by a metal catheter into the leaf valve mechanism

From 1992 to 1996, 189 Mentor Model 1800 saline breast implants were inserted into patients (54 for breast augmentation and 135 for replacement of explanted silicone gel implants). Nine of these implants (4.8%) spontaneously deflated at a mean time of 2.8 months postoperatively (range 0.5 to 10 months) (Table 1). Six deflations were partial (10% to 50% of implant volume) (Figure 1), and three were complete (Figure 2). The failure times of all nine implants are shown in Table 1. All failed implants were from the same manufacturer and had the same leaf valves (Mentor Model 1800) (Figure 3). This type of implant is filled by introducing a metal catheter into the leaf valve mechanism.

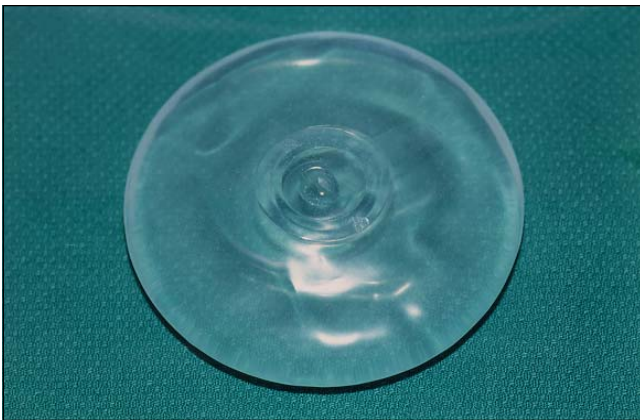
**Figure 4)** A refilled failed implant that was left on a flat surface overnight demonstrating a large drop of saline at the external site of the valve

left on a flat surface, they demonstrated a slow leak through the external leaf valve mechanism – as slow as two to three drops per 12 h (Figure 4). This rate increased when pressure was applied to the implants. When an implant was left on a paper towel, a large ring of saline formed around the implant over 6 to 8 h (Figure 5).

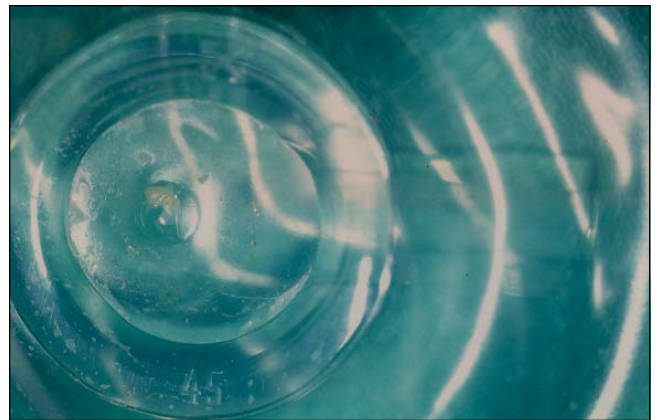
**Figure 6)** In three of the implants with delayed leakage (Table 1), fibrous tissue was observed in the valve mechanism. This may have served as a 'wick' to stimulate fluid leakage

In three of the implants with delayed leakage (three to nine months, Table 1), fibrous tissue ingrowth was observed in the leaf valve mechanism of the deflated implants (Figure 6). It is postulated that failure in all nine implants resulted because of defects in their valves and that tissue ingrowth into the leaf catheter valve mechanism may have played a role in at least three of them. This tissue may have provided a 'wick' to stimulate fluid leakage.

In three implants (implants 7 to 9), fibrous tissue was demonstrated in the valve mechanism (Figure 6)

Since May 1996, no further Mentor Model 1800 leaf valve implants have been used by the author. These implants have been replaced by the Mentor Model 1600 diaphragm valve implants (with plugs). No failures have been observed in any of the 68 diaphragm valve implants that have been inserted into patients during the past year.
